CITY OF KINGSTON WASTEWATER MASTER PLAN

CONDITION ASSESSMENT REPORT -
WASTEWATER

JANUARY, 2017

Final Report

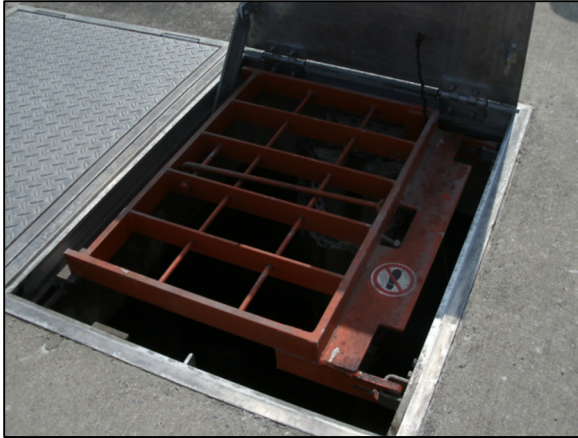
Figure 7-1 Palace Road PS – Safety Grate (Photograph)

Palace Road Pumping Station has safety grating fitted to it's well hatches. This would be a valuable addition to other wells in terms of safety. During times when hatches are opened for inspection, the grating would serve as an extra preventative measure to stop staff or members of the public from falling into wells (Figure 7-1).

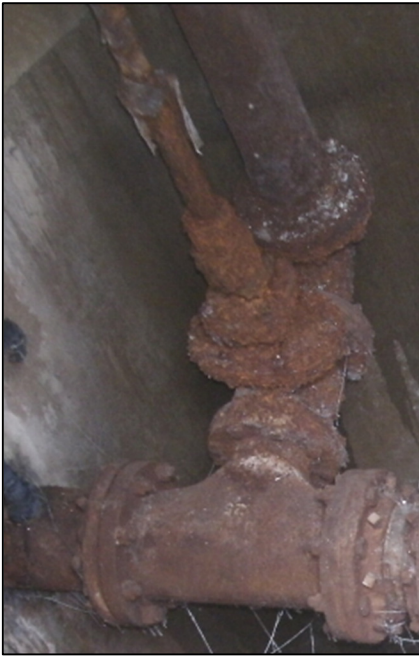
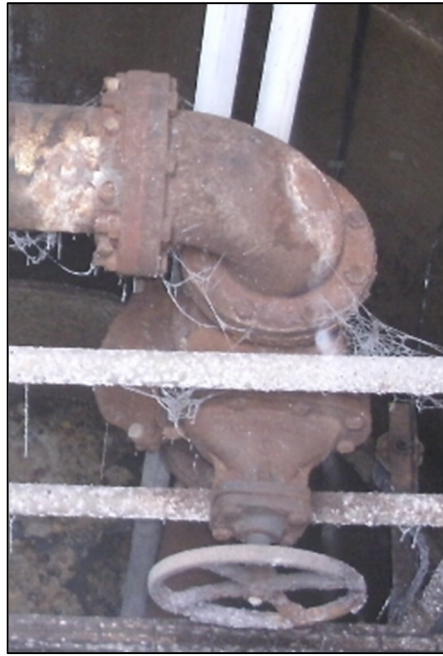
Figure 7-2 Kenwoods Circle PS – Isolation Valves (Two Photographs)

In most cases, valves do not appear to be maintained until there is a repair required. Turning the valves on, on a regular basis, to keep the valve in a good state of repair will allow operators to operate these valves without difficulty.

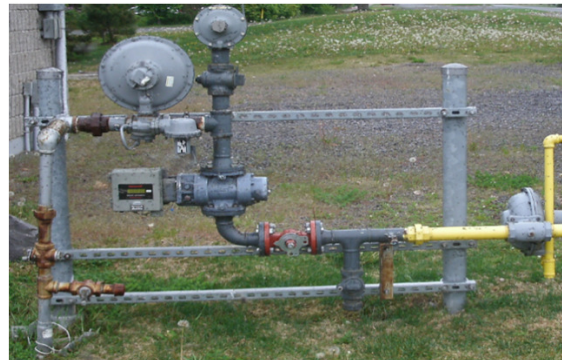
Gas Piping not to CSA B149.1 – entire piping system above ground should be painted yellow

(\$500)

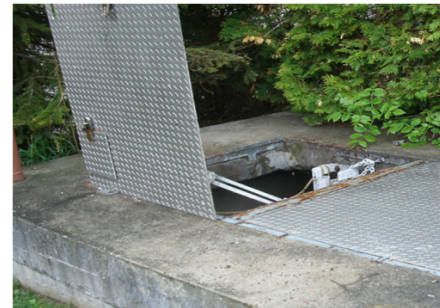
- 1) Repair Hinges on Well hatch. (\$ 200)
- 2) Hatches open in the wrong direction - (\$ 1,000)
easier to maintain the well if they
opened in the opposite direction, away
from the building
