**POINT PLEASANT  
WATER TREATMENT PLANT EXPANSION**

**TECHNICAL MEMORANDUM NO. 2  
EXISTING FACILITY CONDITION ASSESSMENT  
AND TREATMENT LIMITATIONS**

May 2009

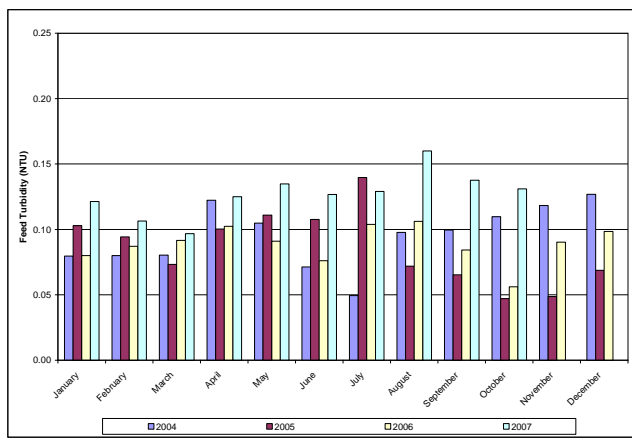
Figure 1a –Filter #1 Average Monthly Effluent Turbidity

When examining the individual filter effluent turbidity summarized in Figures 1a, b, and c, there are differences seen both seasonally and between individual filters. Filters #1 and #2 follow similar trends regarding both average effluent turbidity and elevated turbidity during late summer – early autumn months. Filter #3, the most recently constructed of the filters, shows approximately 20% higher average turbidity compared to Filters #1 and #2, and shows higher turbidity during spring and early summer. This difference may be a result of differing loading rates between the filters, different flocculation conditions, differing filter media distribution or differing filter underdrain condition.

While the elevated turbidity events for the individual filters do not exceed the current 0.3 NTU regulation, they are consistently above the 0.1 NTU individual filter effluent (IFE) recommended as the design target outlined in Technical Memorandum No. 1. Jar testing in 2002 showed that a coagulant dose of 5 mg/L of PACl would result in a lower effluent turbidity and organics removal compared to the current dose of 0.8 – 1.2 mg/L. As such, modifications to the coagulation and flocculation process (coagulant dose, pH, flocculation mixing characteristics, etc.) could improve the individual filter effluent turbidity and should be examined as part of the Point Pleasant WTP expansion.
