Utilities Kingston Pole Collapse Investigation

John Counter Blvd

(Sir John A. MacDonald Blvd. to west of Indian Road)

For Utilities Kingston, Kingston, Ontario.

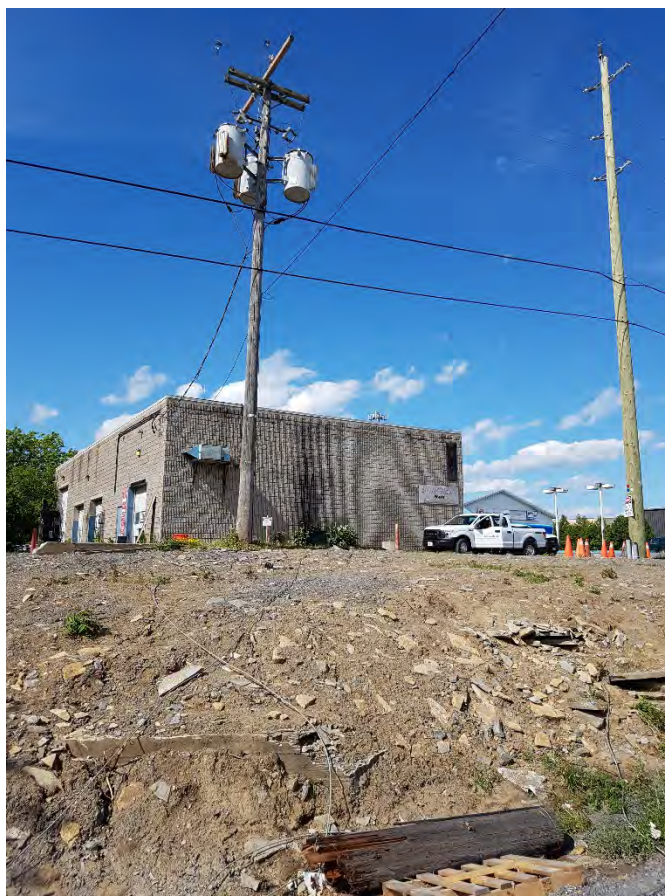
HP #3230

- passed Polux test with 75% remaining strength
- no sign of insects
- passed core drill testing

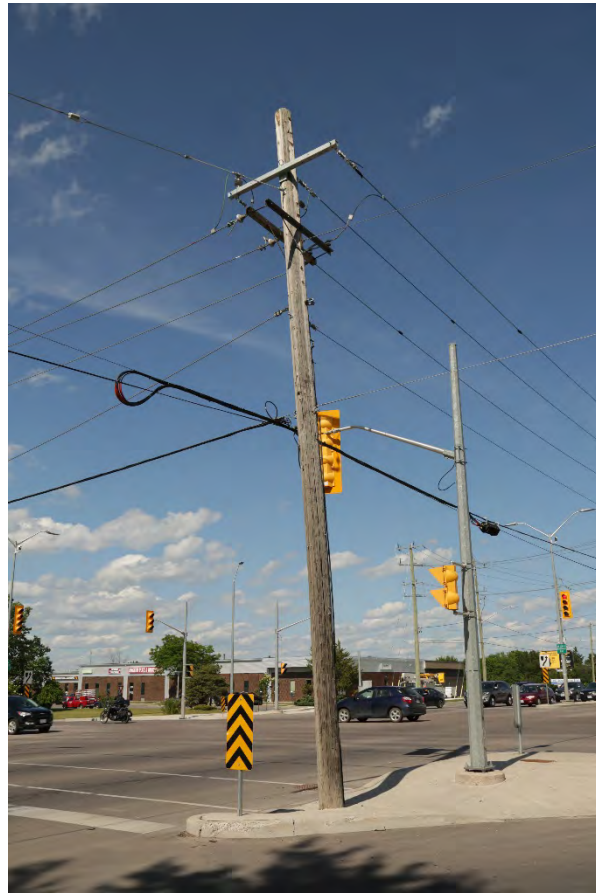
HP #3276

- The adjacent pole P#3276 on the traffic island on the south west corner of Sir John A. MacDonald and John Counter Boulevard that did not collapse passed the Polux test with 80% remaining strength and no signs of insects as well as passing the drill test.
- On P#3279 there were signs of insect infestation 1.219m to 1.524m above the ground line.
- Pole Calculations:
 - According to Utilities Kingston there have been no applications submitted for pole attachments from 3rd parties and no major work performed by Utilities Kingston on these poles since the inception of ESA 22/04 and as such there have been no calculations performed on these poles in recent years.
 - Age of the poles has been established based on information provided by Utilities Kingston.

- passed Polux test with 80% remaining strength
- no sign of insects
- passed core drill testing

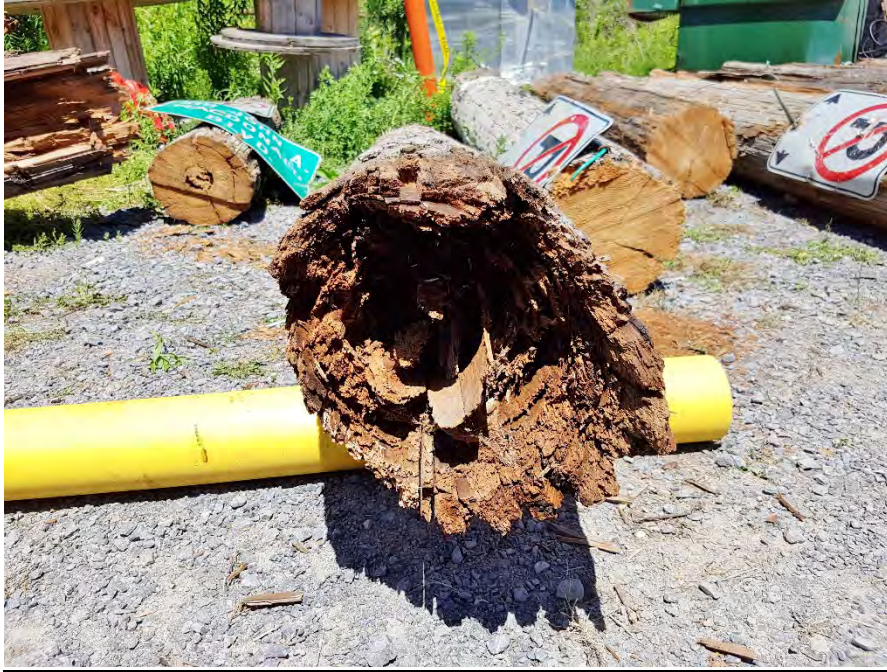
HP #3279

-failed Polux test (strength too low to record)

-severe insect infestation above ground line

-no core drill test was performed as the pole butt was missing

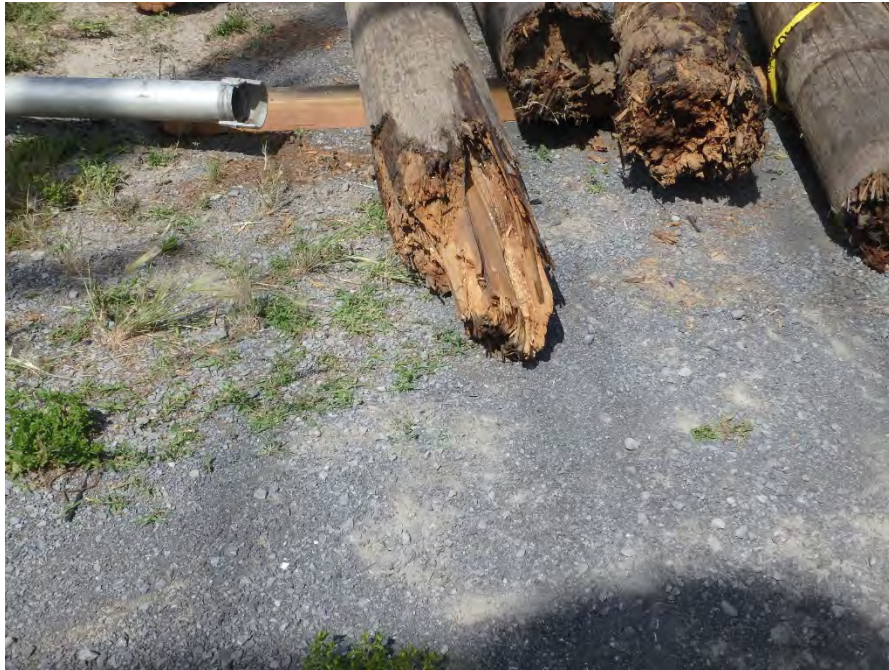
HP#3280

- Insufficient depth of set P#3280:
 - Depth of set was established at approximately 0.91m (3'). Depth of set should be 1.8m (6').
- Sounds of pole cracking:

-passed Polux test with 62% remaining strength

-depth of set approximately 0.91m (3'). Should be at 1.8m (6').

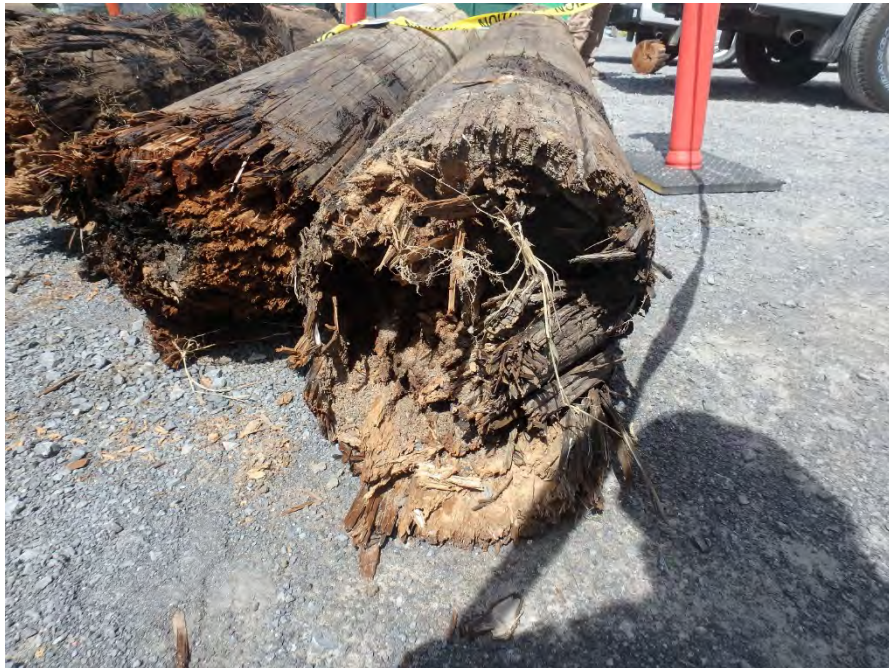
HP#3281

-failed Polux test with 56% remaining strength

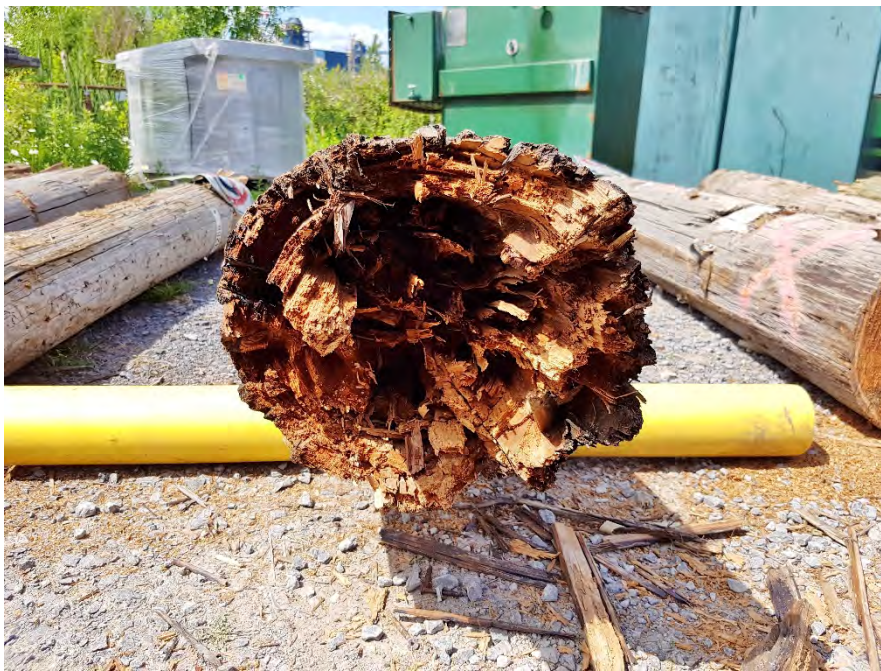
HP #3282

-passed Polux test with 73% remaining strength

-insect infestation

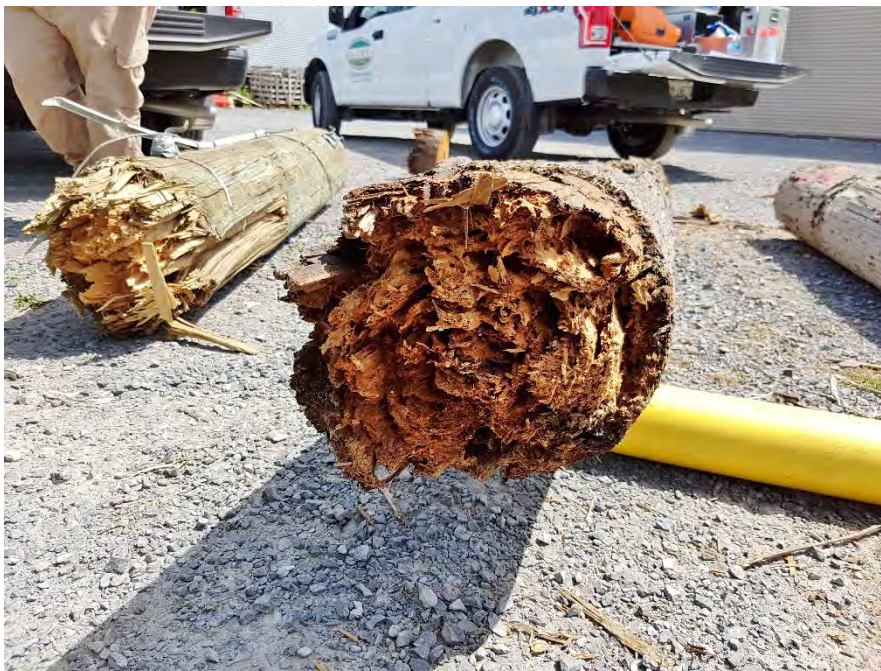
HP #3283

-failed Polux test with 52% remaining strength

-insect infestation

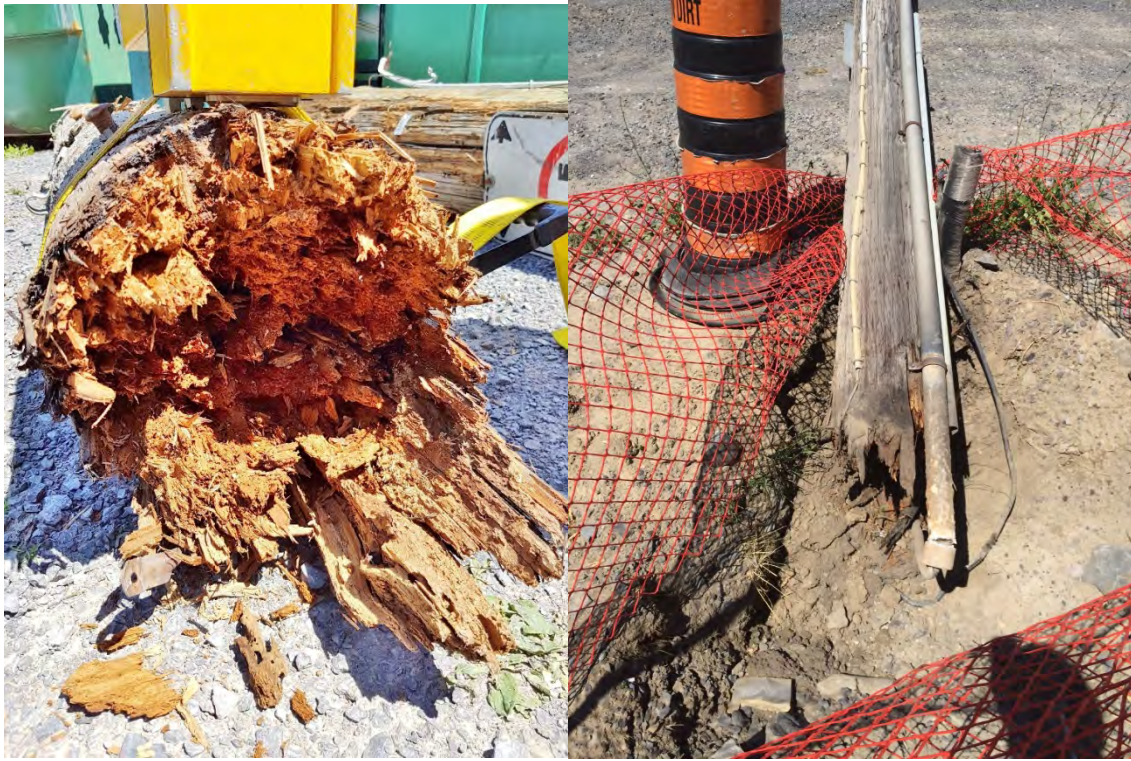
HP #3284

- Open pit on the south side of P#3284:
 - During the construction of the Utilities Kingston buried vault a trench was excavated to the base of P#3284. The exposed pole base on the south side was left open.

- The photo of this pole (see Attachment #1 Pole Testing Results for P#3284) shows that the failure (break) occurred below the ground line where it was deteriorated from the inside out.

-failed Polux test with 41% remaining strength

-severe insect infestation

-failed core drill test, drilling produced no shavings and required very little effort

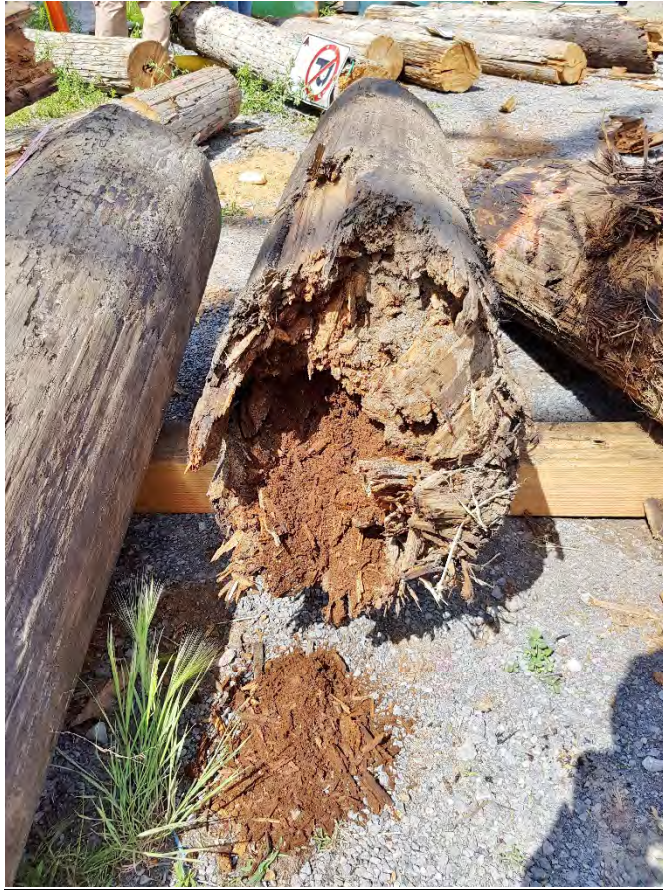
HP #3285

-failed Polux test (strength too low to record)

-severe insect infestation

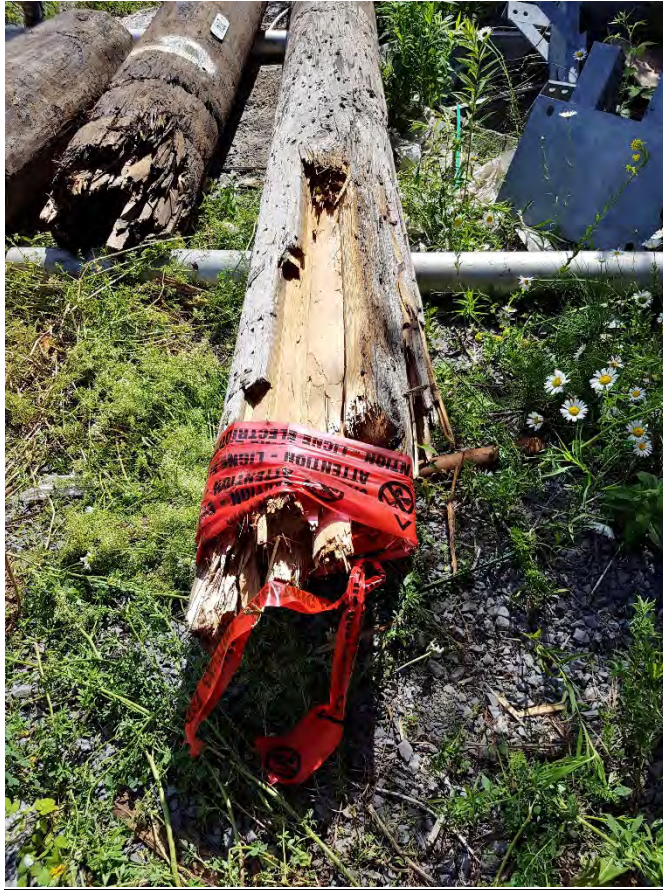
HP #3286

-failed Polux test with 57% remaining strength

-no sign of insects

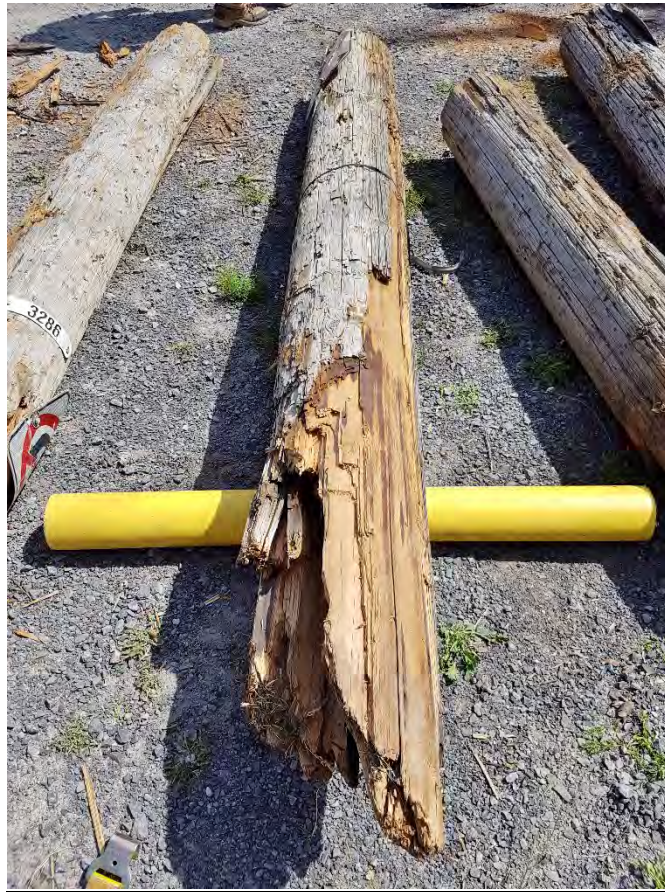
HP #3287

-failed Polux test (strength too low to record)

-insect infestation
