Utilities
Kingston

**PORTSMOUTH PUMPING FLOW DIRECTION
AND FRONT ROAD TRUNK WATERMAIN
INTERCONNECTION**

HERITAGE IMPACT STATEMENT

—
Utilities Kingston
131-18048-00
June 2014

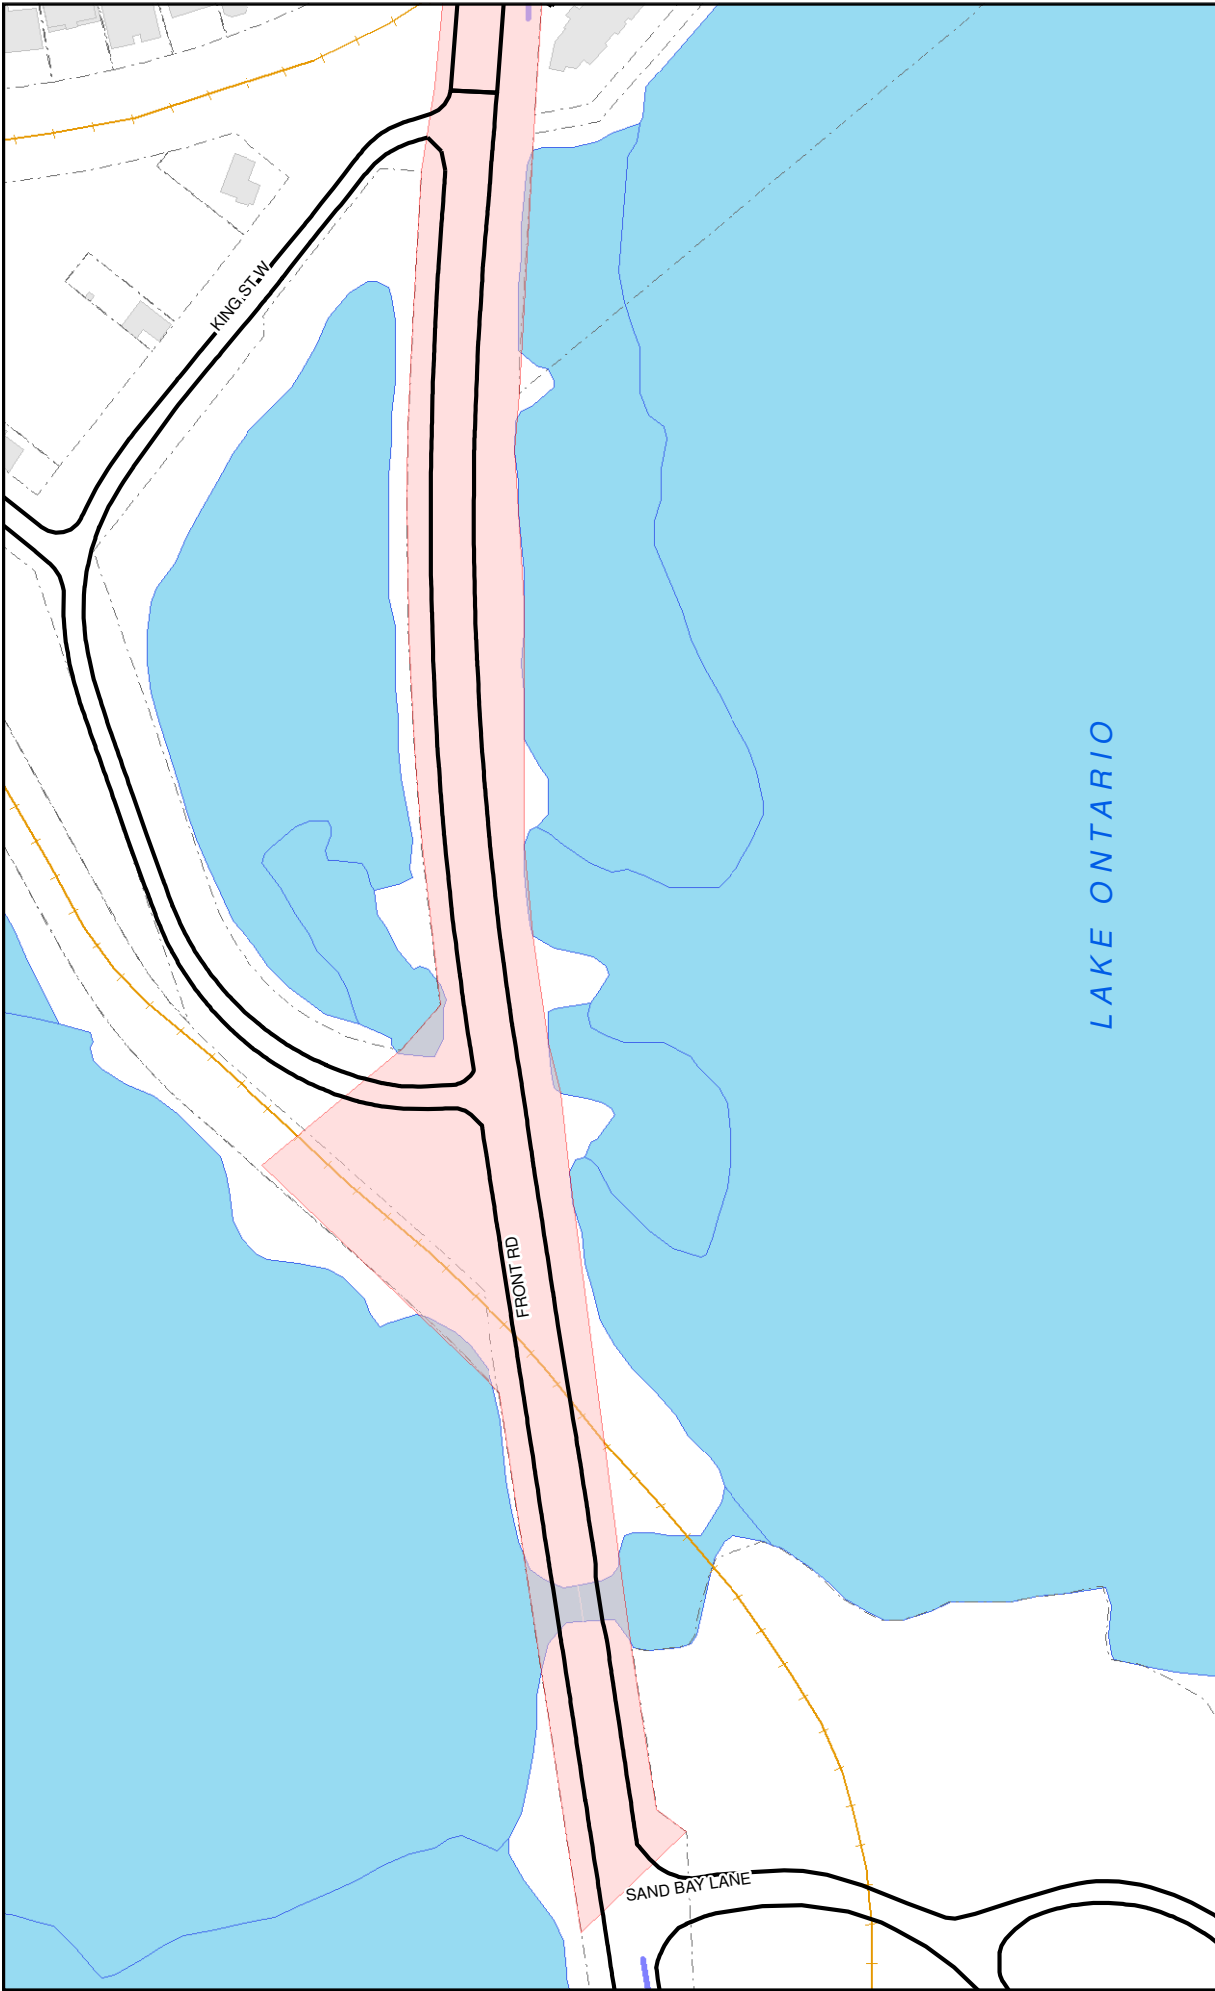
<p>Legend</p> <ul style="list-style-type: none"> Study Area Water Storm Sanitary 	<p>TITLE: CATARAQUI CREEK CROSSING</p>	<p>MAP 4</p>
	<p>DATE: SEPTEMBER, 2013</p> <p>PROJECT: 131-18048-00</p> <p>SCALE: 1:2,500</p> <p>0 20 40 80 Meters</p>	
<p>Portsmouth PS Flow Direction & Front Rd Trunk Watermain Interconnection: City of Kingston, Ontario</p>		<p>Utilities Kingston</p> <p>UTILITIES KINGSTON P.O. BOX 790, KINGSTON, ONTARIO, K7L 4X7</p>
<p>WSP</p> <p>1224 GARDINERS RD. SUITE 201 KINGSTON, ONTARIO, CANADA, K7P 0G2 WWW.WSPGROUP.COM</p>
