CITY OF KINGSTON WASTEWATER MASTER PLAN

CONDITION ASSESSMENT REPORT -
WASTEWATER

JANUARY, 2017

Final Report

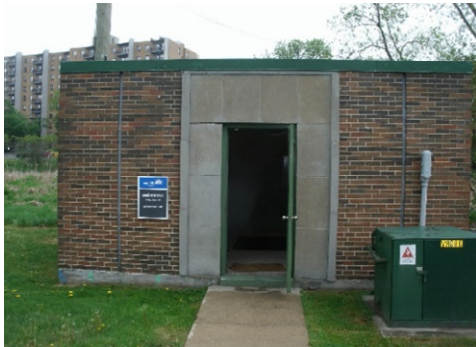
Photo: Exterior

Structural: **Access wasn't available to well during condition assessment, Operator stated that there is no issues and PS has a low flow.**

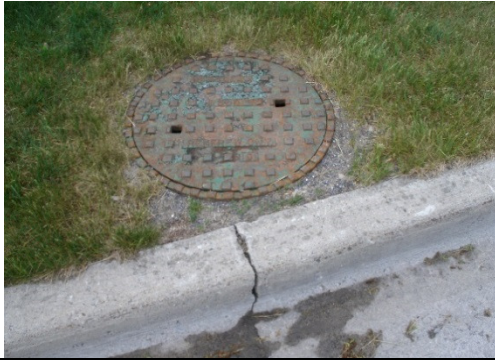
Photo: Exterior

- Civil / Site: **Good Condition**
- Structural: **Good Condition. Large Access way hatches have no handles.**
- Proc. Mech.: **Piping and Valving corroded.**
- Instrument: **Good Condition. System not fully calibrated.**
- Proc. Elec.: **Good Condition. Deisel Generator - in good working order**
- Build. Mech.: **Good Condition. Diesel Tank banded**
- Build. Elec.: **Good Condition.**

Upgrade 1:
 Replace Pipework, Valves, Sensors/Transmitters and Instrument panel.

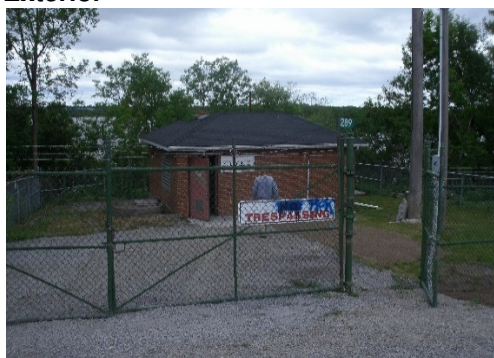
Photo: Exterior

Structural: **Wet Well not assessed. Dry well shows signs of water damage.**

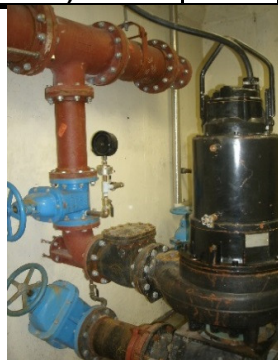
Photo: Interior

Proc. Mech.: **Aging Pumps - evidence of leakage and corrosion. Piping and Valves starting to show signs of corrosion.**

Instrument: **Pump Control Panel beyond design life capacity - should be replaced. Pump Starters recently installed.**

Replace Pump Control Panel as it is beyond Life expectancy (\$ 40,000)

- 1) Replace Pumps, Sensors/Transmitters, Instrument panel and Building Mechanical.
- 2) Consider replacing Pipework and Valves (Not included in costing).

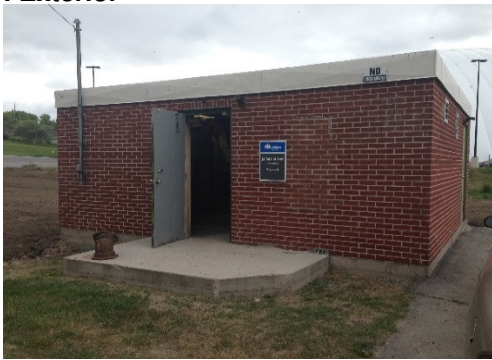
Photo: Exterior

Civil / Site: **New facility. Repair required to paving.**

Damaged Paving to be repaired (\$ 3,000)

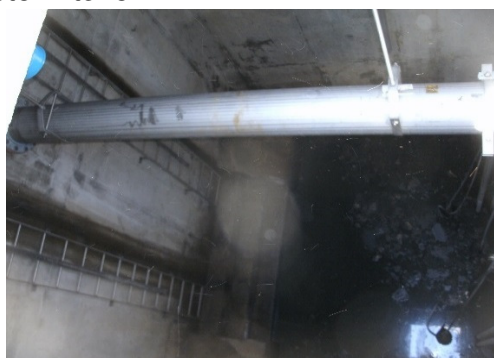
Photo: Interior

Proc. Mech.: **Piping and valves heavily corroded. Valves may be corroded in place making difficult to operate.**

- 1) Replace pipework and valves

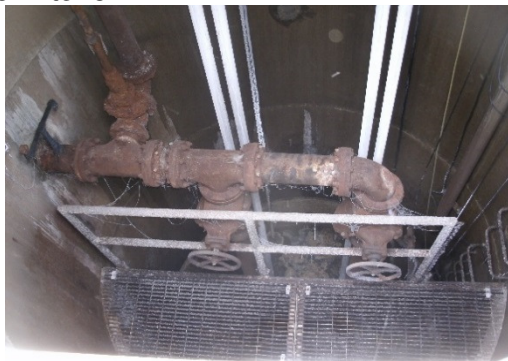
Photo: Interior

Structural: **Wet Well not assessed. Dry well shows signs of water damage on areas around pump suction - has been repaired using Polyurethane Injection. New Tin roof.**

Proc. Mech.: **Piping in good Condition. Valves starting to show signs of corrosion. George Street CSO used to control flow levels. Grider recently repaired.**

Replace Furnace as it is beyond Life expectancy (\$ 7,000)

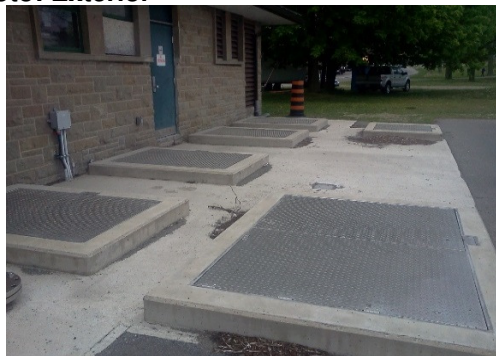
Photo: Exterior

Structural: **Good Condition. Hinges on one well hatch broken. Well would be easier to access if hatches opened in opposite direction.**

- 1) Repair Hinges on Well hatch. (\$ 200)
- 2) Hatches open in the wrong direction - (\$ 1,000)
easier to maintain the well if they
opened in the opposite direction, away
from the building

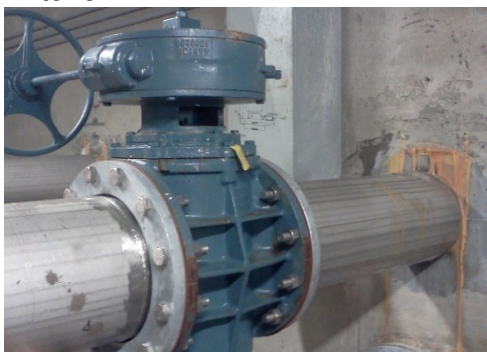
Photo: Interior

Proc. Mech.: **Piping and Valving heavily corroded.**

- 1) Replace Pipework, Valves, Instrument Panel and Sensor/Transmitter.
- 2) Consider upgrade 2 during this work. (See Upgrade 2 Price)

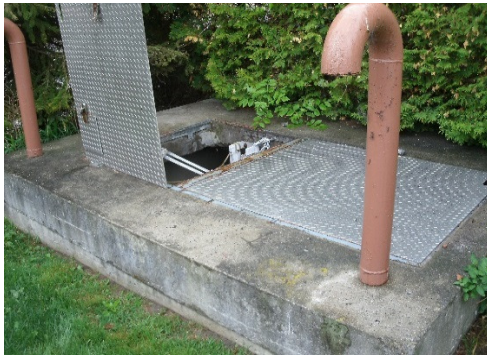
Photo: Exterior

- Civil / Site: **Good Condition - Low Flow station (Only used in summer months.)**
- Structural: **Metal structure with some slight signs of corrosion.**
- Proc. Mech.: **Pumps, Piping and Valves not visible - operator stated that there was no issue.**
- Instrument: **Ok Condition**
- Proc. Elec.: **Good Condition**
- Build. Mech.: **N/A**
- Build. Elec.: **N/A**

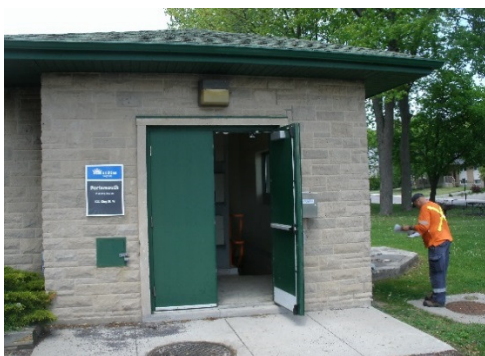
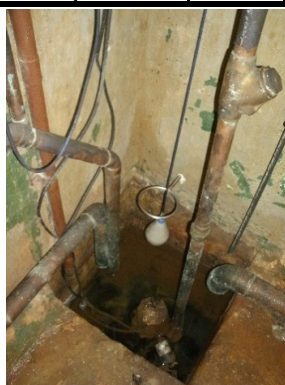
- Civil / Site: **Good Condition - Gravel Compound**
- Structural: **Good Condition**
- Proc. Mech.: **Piping and Valves showing corrosion**
- Instrument: **Aging Pump Control Panel - Ok Condition. SCADA data appears to show the Flowmeter is not currently working.**
- Proc. Elec.: **Generator Controller is beyond expected life expectancy.**
- Build. Mech.: **Good Condition. Generator Tank is banded.**
- Build. Elec.: **Good Condition**

- 1) SCADA data shows Flowmeter is not currently working or undersized – review and repair/replace (\$ 20,000.00)
- 2) Generator Controller is aged beyond expected life and should be replaced. (\$ 10,000.00)

- 1) Replace Pump Control Panel
- 2) Consider upgrade 2 during this work. (See Upgrade 2 Price)

- 1) Replace Instrument Panel, Sensors/Transmitters, Pipework and Valves.

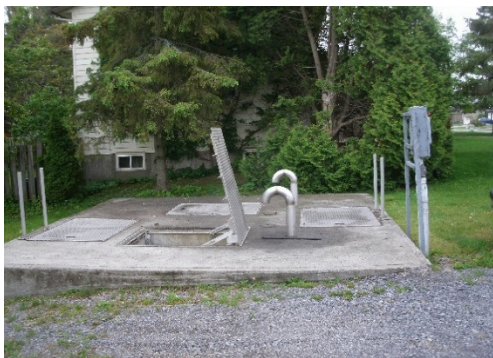
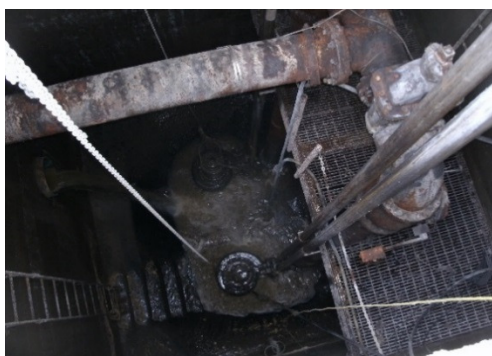
- Civil / Site: **Good Condition**
- Structural: **Wet Well not assessed. Dry well shows signs of water damage on areas around pump suction.**
- Proc. Mech.: **Piping and Manual Valves starting to show corrosion. Overflow to Sanitary Sewer never used.**
- Instrument: **SCADA data appears to show the Flowmeter is undersized for the capacity of the PS**
- Proc. Elec.: **Good Condition. Portable back-up generator**
- Build. Mech.: **Good Condition**
- Build. Elec.: **Good Condition**

SCADA data shows Flowmeter is not currently working or undersized – review and repair/replace (\$10,000)

- 1) Replace Instrument Panels and Sensors/Transmitters

- 1) Replace Pipework, Valves and Pump Control Panel.
- 2) Review Condition of Pumps and consider replacing. (Cost Not included)

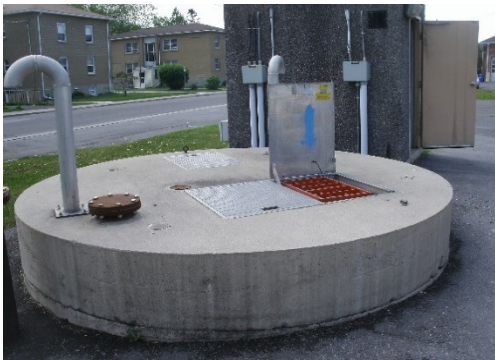
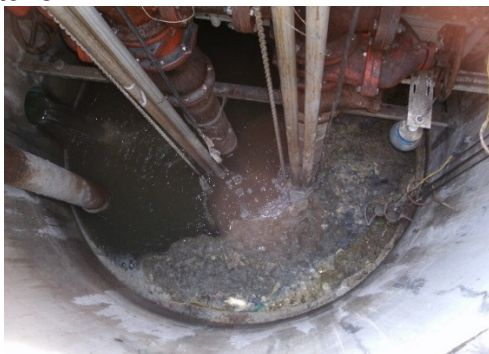
Structural: **Concrete well cap crumbling, rest of well in good condition. Ladder rusting. Roof - slight evidence of leak.**

Proc. Mech.: **Piping and valves heavily corroded - Valves may be corroded in place making difficult to operate.**

Roof Condition to be reviewed - evidence of leak.

- 1) Replace Pipework and Valves.

- 1) Replace Instrumentation
- 2) Review Well Structure and Pumps (Cost Not Included)

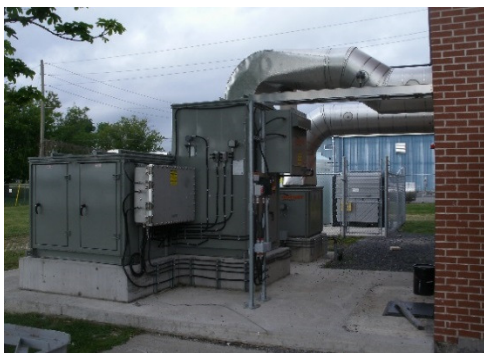
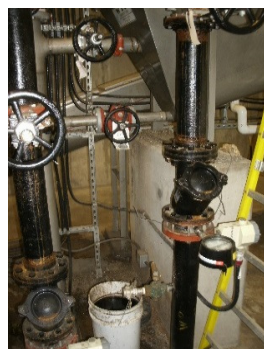
Structural: **Good Condition. Occasional Grease build up**

Proc. Mech.: **Piping and Valves - Corrosion Present**

Upgrade 1:
 Replace Pipework, Valves, Pump Control Panel, Instrument Panel, Sensor/Transmitter

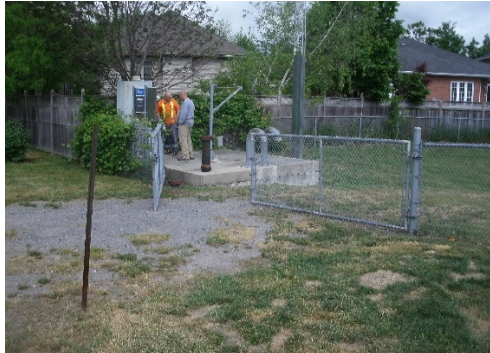
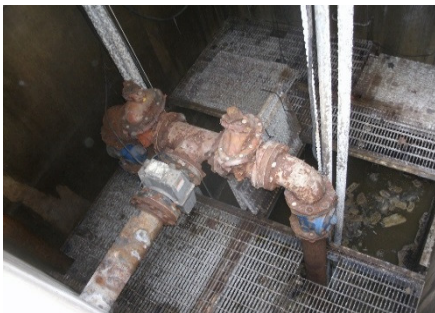
Proc. Mech.: **Well/Pumps do not have the capacity for high flow occurrences (Operator comment). Piping and valves heavily corroded - Valves may be corroded in place making difficult to operate.**

- 1) Replace Pipework, Valves, Pump Control Panel, Sensor/Transmitter and Main Breaker.
- 2) Consider upgrade 2 during this work. (See Upgrade 2 Price)

- 1) Replace Instrument Panel and Pumps
