RAVENSVIEW WASTEWATER TREATMENT PLANT 2021 ANNUAL REPORT

Ravensview Wastewater Treatment Plant Annual Report

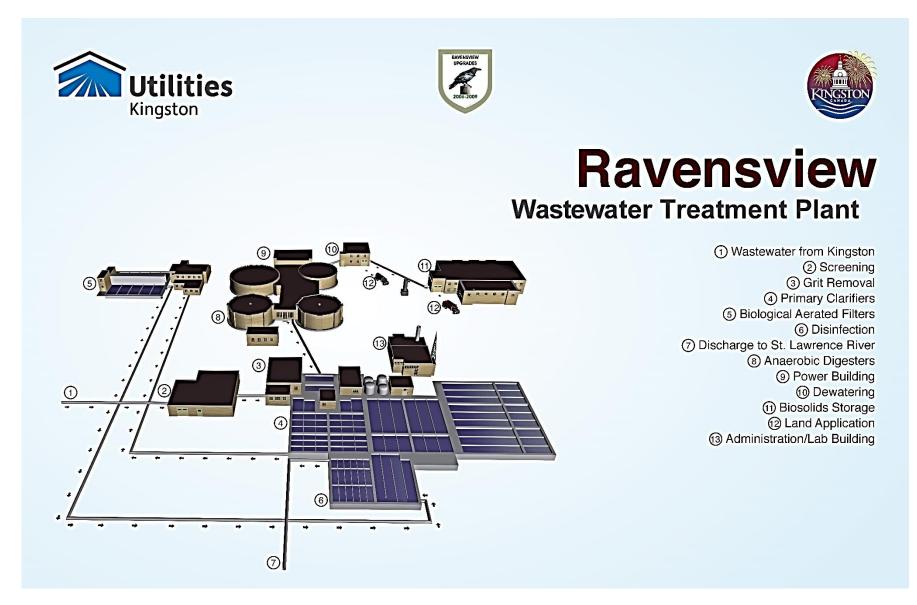
Figure 1 - Ravensview Wastewater Treatment Plant General Layout
